Manhole Inspection Summary

Manhole # S47EE_001MH

Insp Date: **7/21/08 8:48 AM**

Location Address: **Collington**

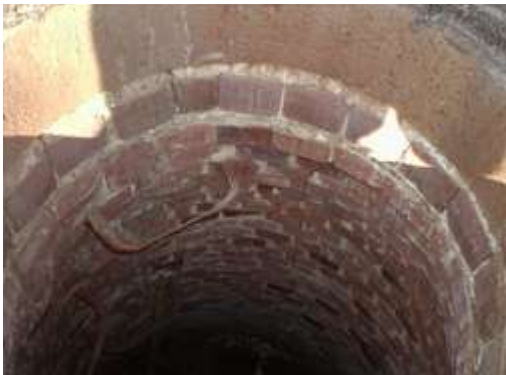
Defect 2

Infiltration

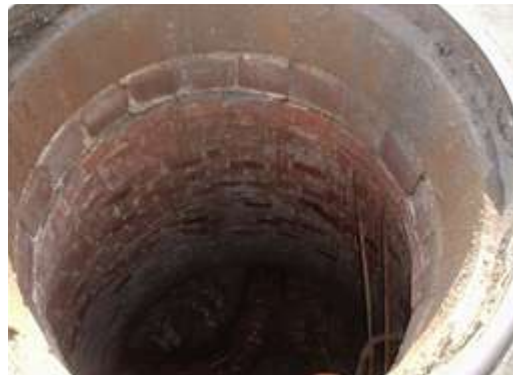
Defect 1

Frame Offset: **0** (in.) Condition: ☐ Sound ☐ Cracked ☒ **Leaks**

Frame leaks

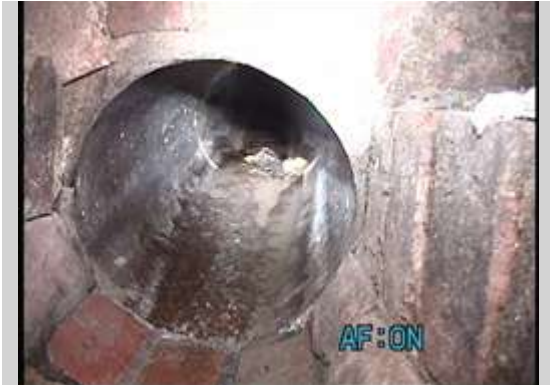
12 O'Clock Outflow

8 in. Circular Gravity Sewer
Pipe Out @ 12 O'Clock

Pipe Height: **8.4** (in.) Rod and Bar (Angled)
Pipe Material: **Clay** ☐ Pipe Lined
Invert Depth: **8.30** (ft.) Flow Characteristics: **Fast**
Deposits: ☒ None ☐ Mud ☐ Sludge ☐ Debris ☐ Grease
Silt Depth: (in.) Deposits Extent:
Infiltration: **None** Pipe Seal Cond: **Sound**

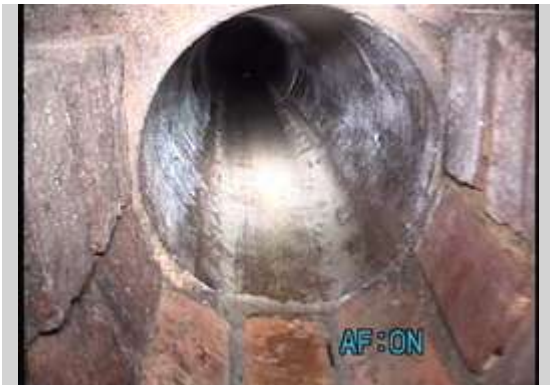
3 O'Clock Inflow

8 in. Circular Gravity Sewer
Pipe In @ 3 O'Clock

Pipe Height: **8.4** (in.) Rod and Bar (Angled)
Pipe Material: **Clay** ☐ Pipe Lined
Invert Depth: **8.10** (ft.) Flow Characteristics: **Fast**
Deposits: ☒ None ☐ Mud ☐ Sludge ☐ Debris ☐ Grease
Silt Depth: (in.) Deposits Extent:
Infiltration: **None** Pipe Seal Cond: **Sound**
